International Atomic Energy Agency

***Radiological Report on an  
Inter-Agency mission to the  
Shinkolobwe mine site***

Democratic Republic of Congo

24 October to 4 November 2004

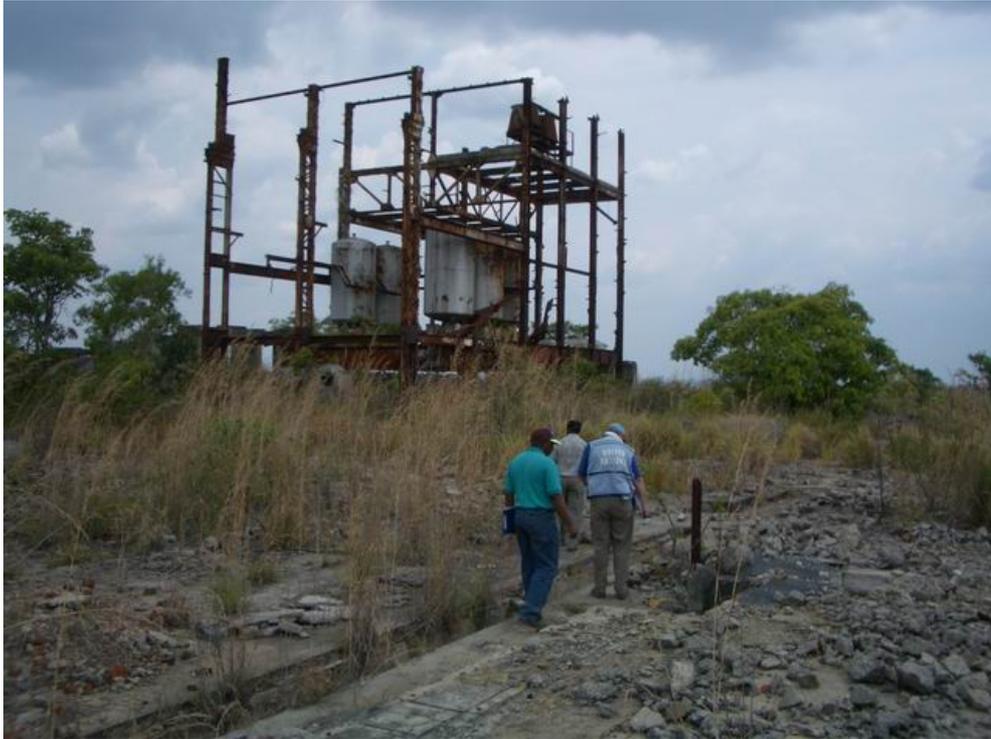
Figure 1: Remnant infrastructure at the former mill area  
(photo: Rene Nijenhuis, Joint UNEP/OCHA Environment Unit)

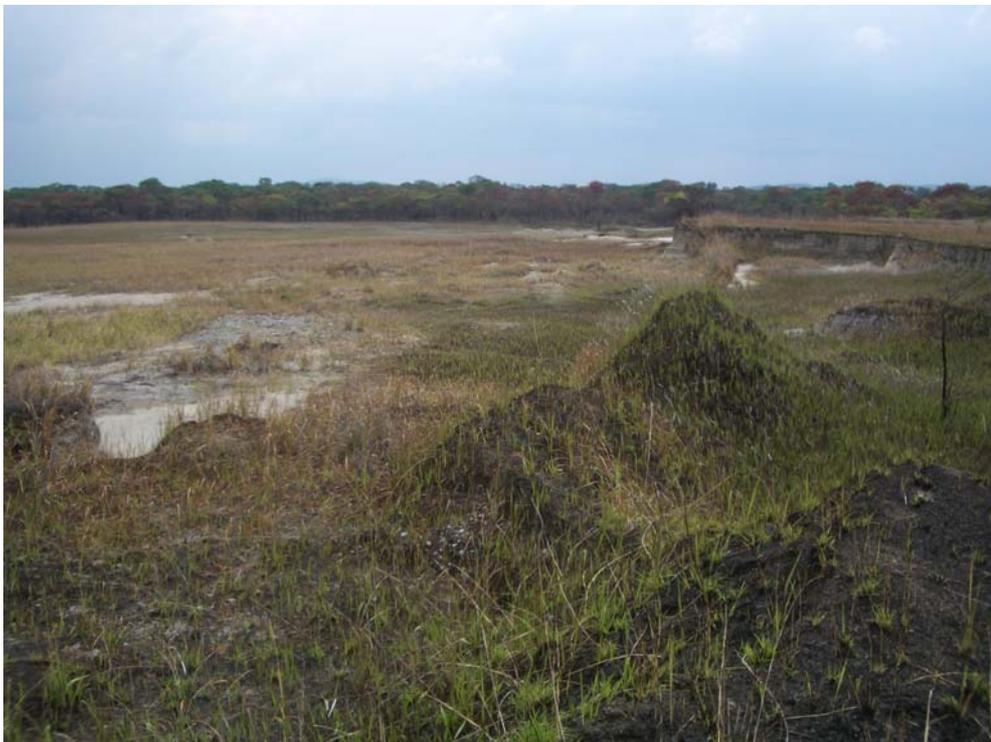
Tailings from the former formal uranium mining operations are exposed and have been “mined” in a few locations (Figure 2); also waste rocks with varying degrees of uranium mineralization may be found all over the site and could represent a radiological safety hazard.

Figure 2: View southwards across western tailings area  
(photo: Rene Nijenhuis, Joint UNEP/OCHA Environment Unit)

relocation of tailings and mineralised waste rocks to the former mine pit and the collapsed workings to the greatest extent possible, and
